Visual Structural Survey
Sampford Brett Village Hall, TA4 4LD

September 2017

Client: Sampford Brett Village Hall Management Committee

Report No. : 2472-R01

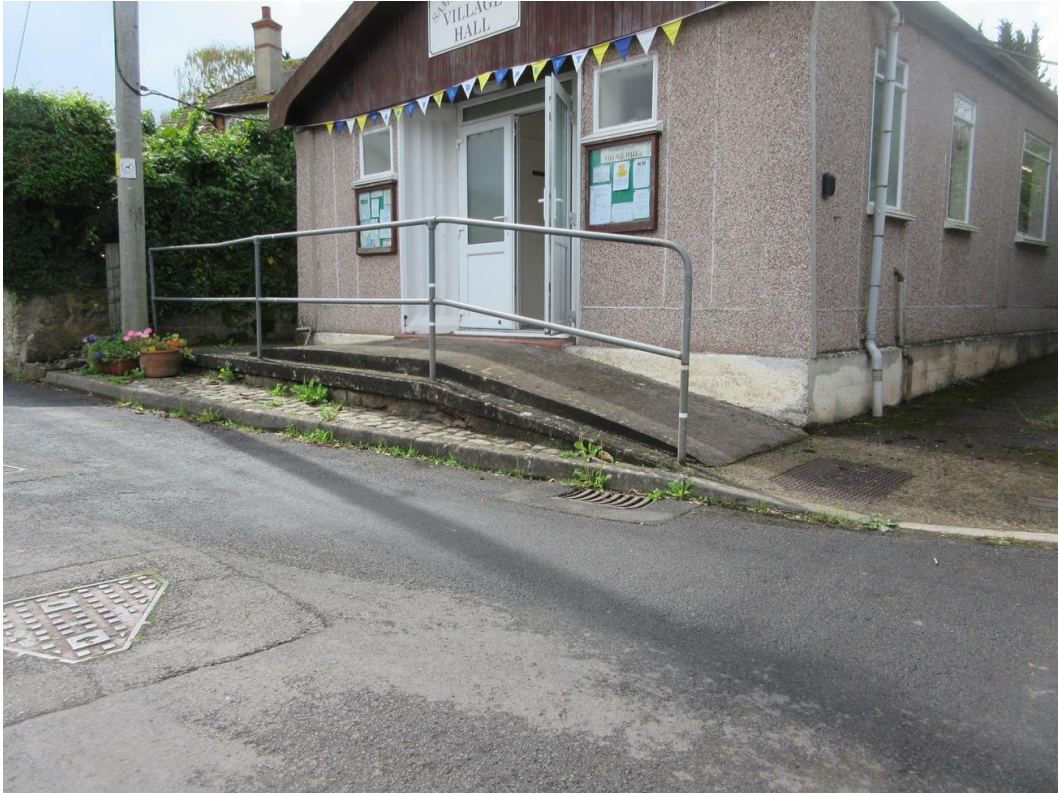
004

The pedestrian access is not ideal for a number of reasons; the ramp is too steep to be easily used by wheelchair users and does not meet current DDA requirements (004) and building users leaving/arriving at the facility have no refuge or footpath alongside the carriageway before having to step directly onto the roadway (005).

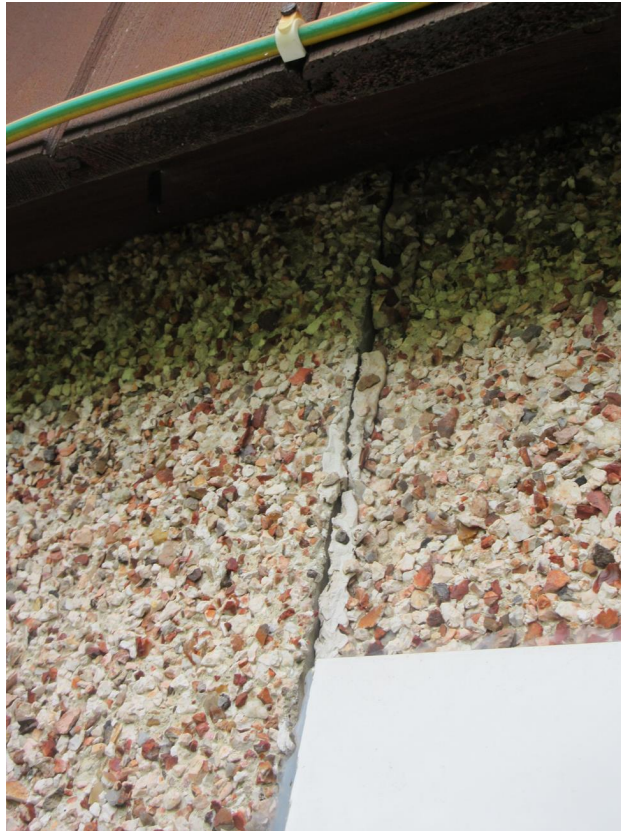
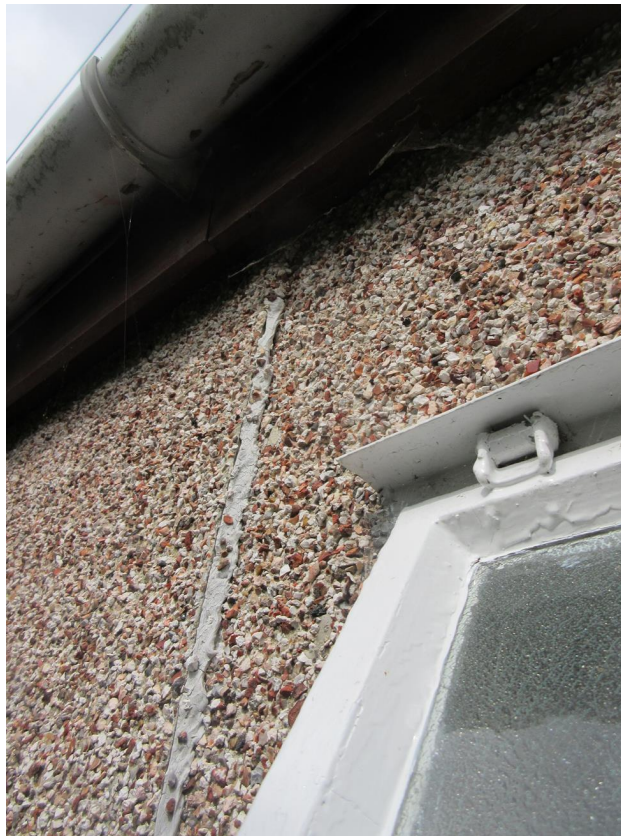
Externally the village hall walls are formed from segmental precast concrete panels which have been cast with a "fine pebble dashed" finish. The modular concrete panels directly form window and door openings with their surrounds. The precast concrete panels are joined together with a mastic type sealer which is now brittle and aged. The sealer, in some places, is split and needs to be resealed to prevent water ingress into the internal fabric of the walls (006 and 007).

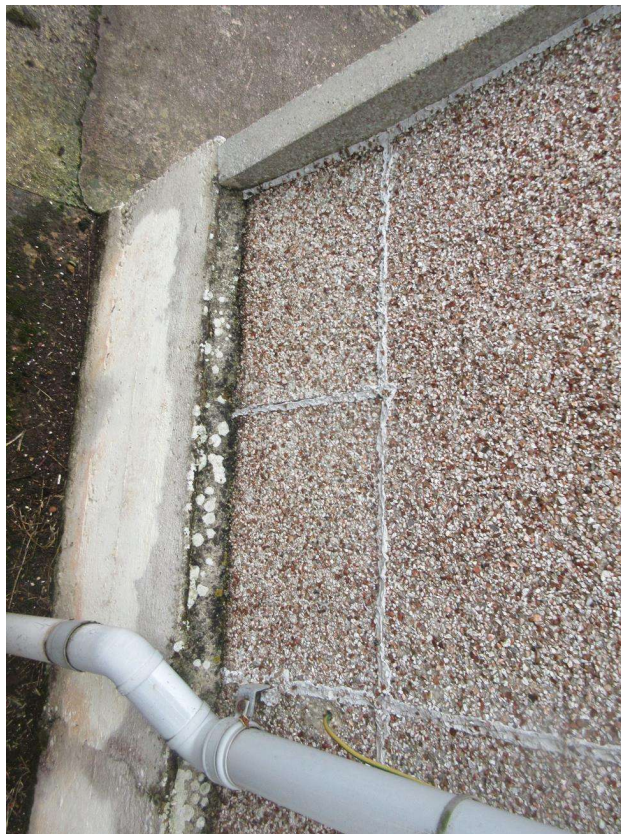
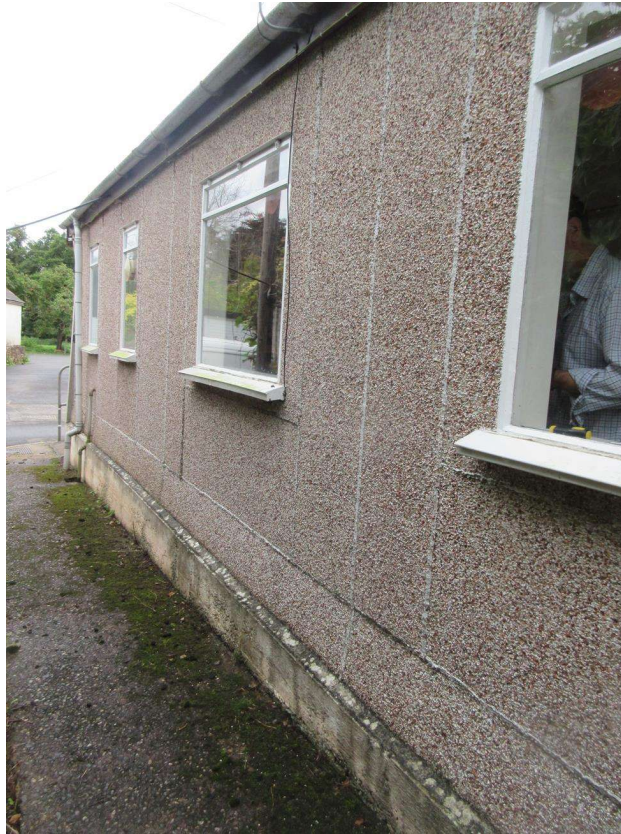
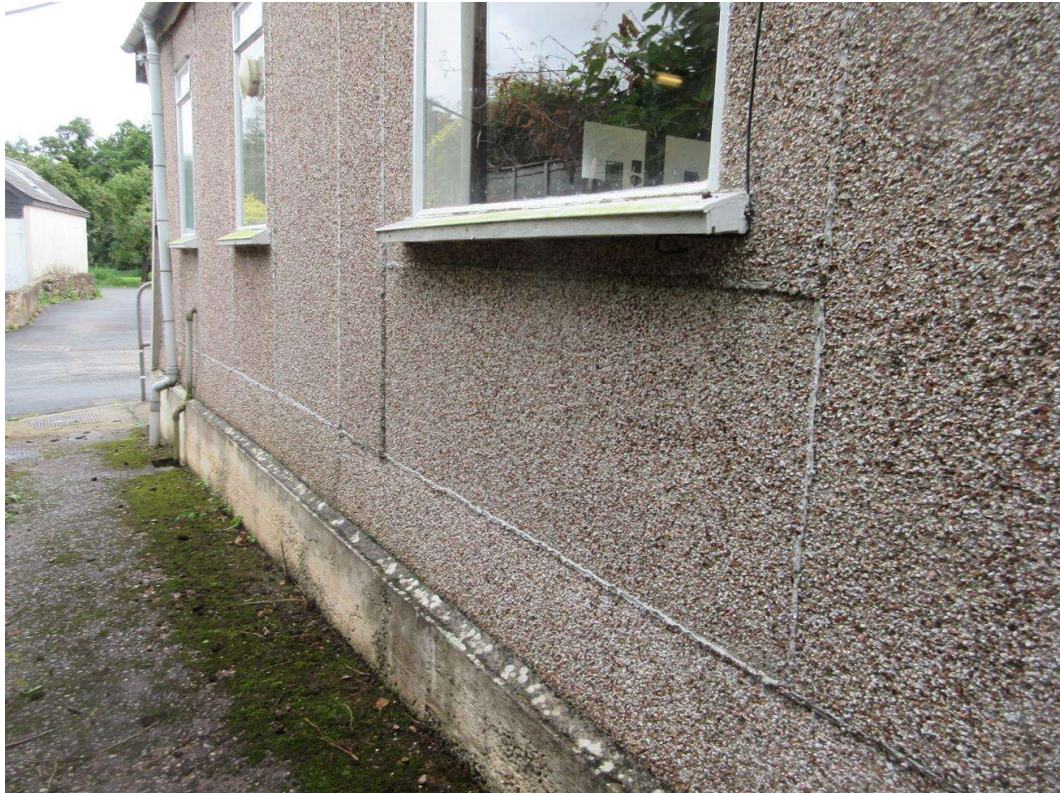
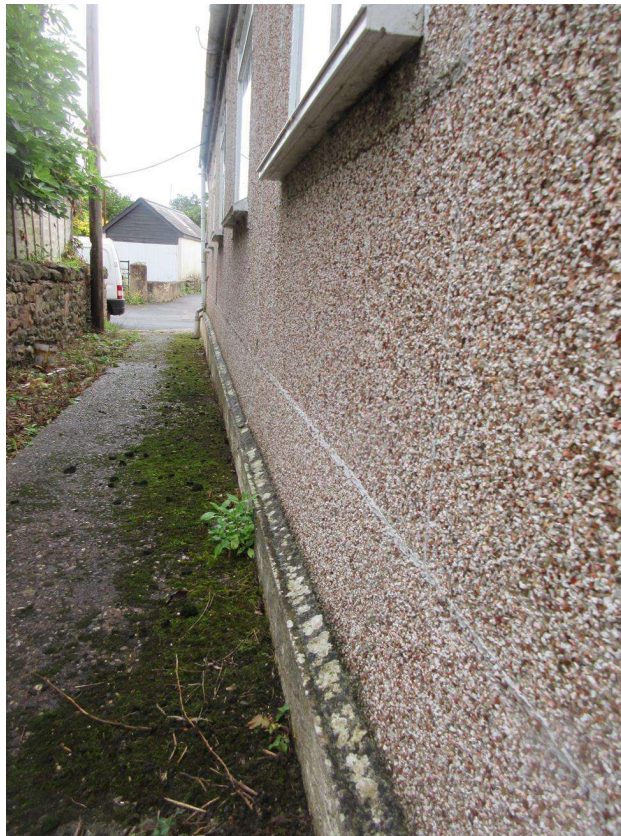
The joints between the concrete panels are not even nor planar in many places which does indicate that the alignment and fixing relationship of the elements has altered over the years. The local movement and displacement of the joints is normally attributed to either degraded fixings or corrosion expansion of the fixing cleats and their packing shims (008 to 011 inclusive).

The actual condition and integrity of the pre-cast concrete panel retention system is not known but the joints indicated that the assembly fixing arrangement is degraded, the extent of which is not fully known. It must be remembered that this system building is about forty five years old and would have originally been theoretically designed for a service life of about fifty or sixty years. The removal of the internal lining board in a few locations would allow closer inspection of the condition of the brackets, fixings and shim packs.

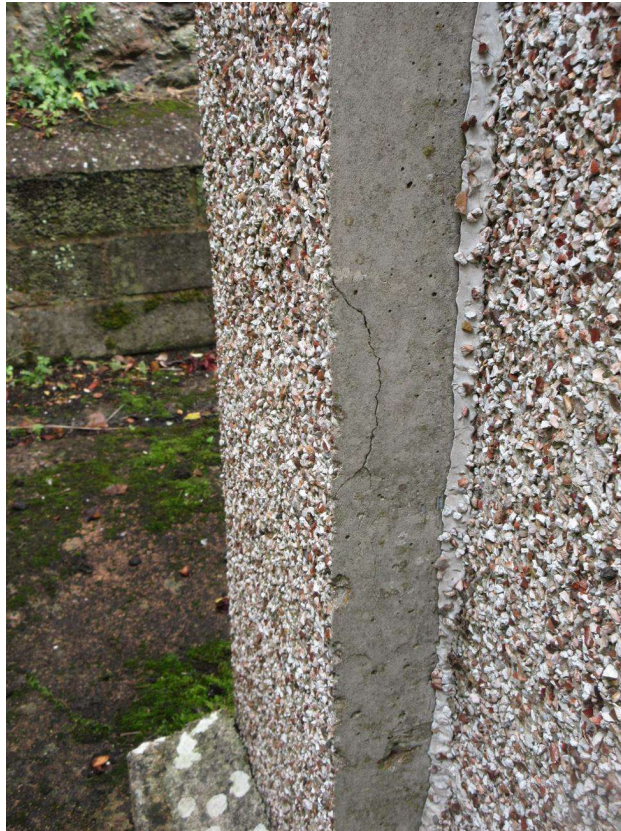
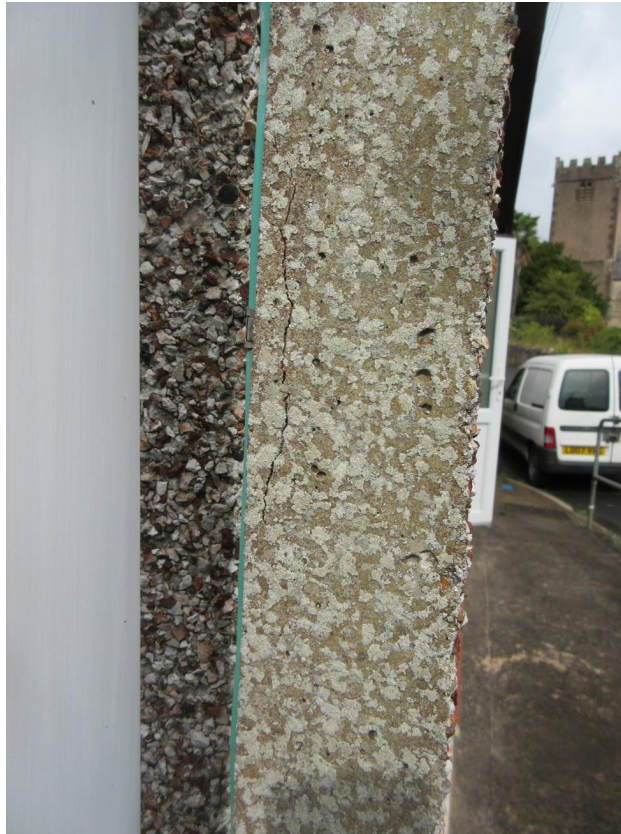
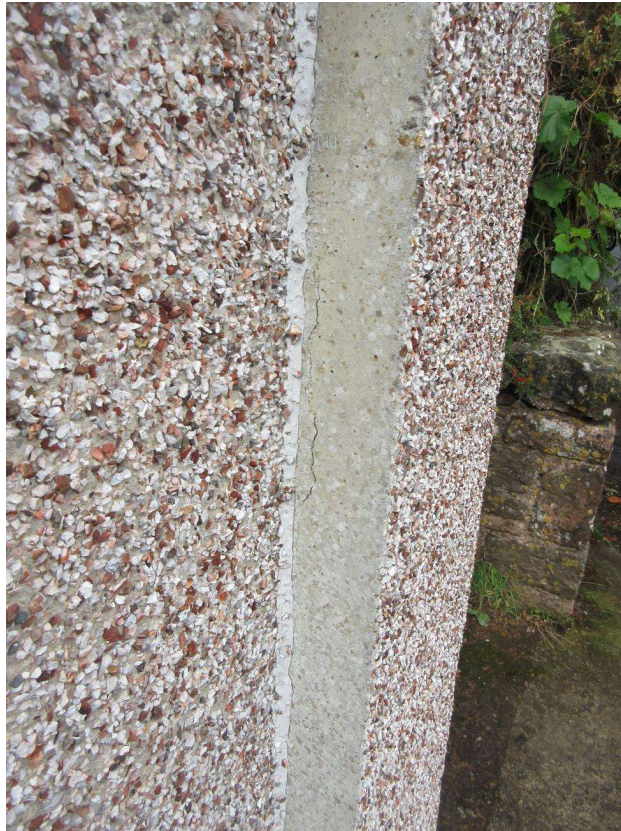
The general condition of the precast concrete cladding panel elements appear to be reasonable and not particularly visually degraded. The 75mm concrete corner cloak panels do exhibit some linear edge cracks which probably is due to advanced corrosion jacking caused by the expansion of the contained ferrous edge reinforcing steel. The limited cover to the steel and carbonation of the concrete has allowed this process to occur (012, 013 and 014).

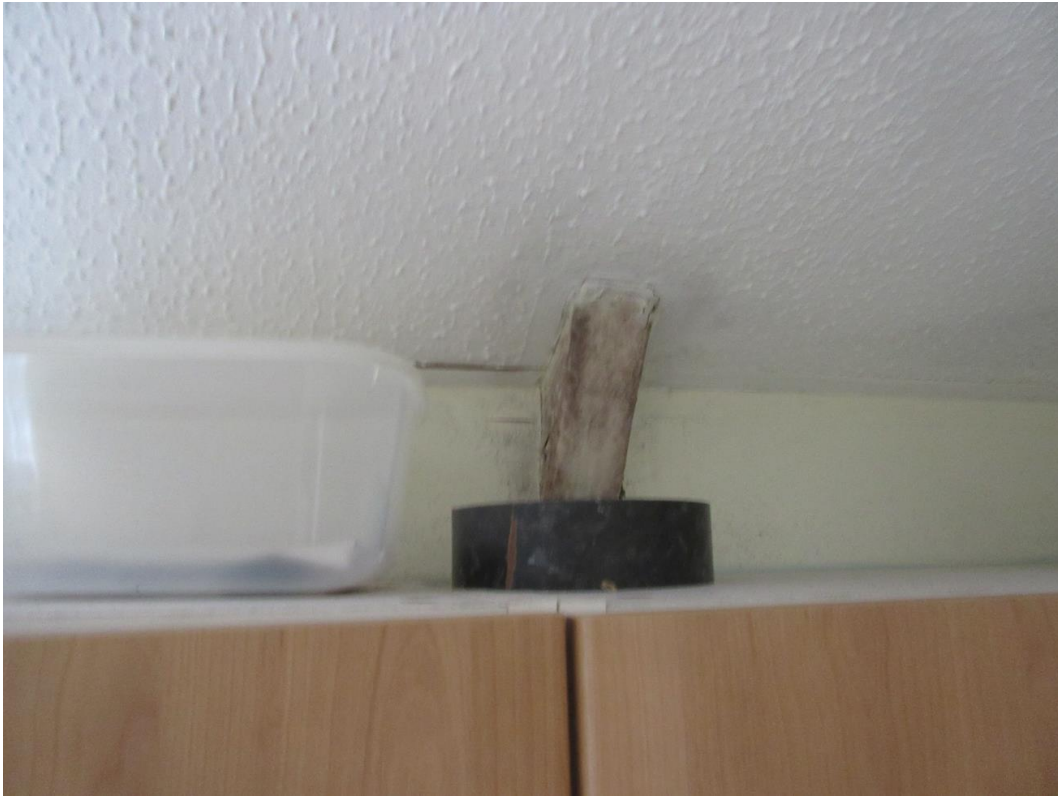
017

The local staining appears to be due to overflowing gutters and a little from condensation around the exposed steel haunch sections (017).

There is some minor water marking of the ceiling in a few places, this staining appears to be from a combination of either overflowing/leaking eaves gutters and/or localized condensation around the exposed steel framework.

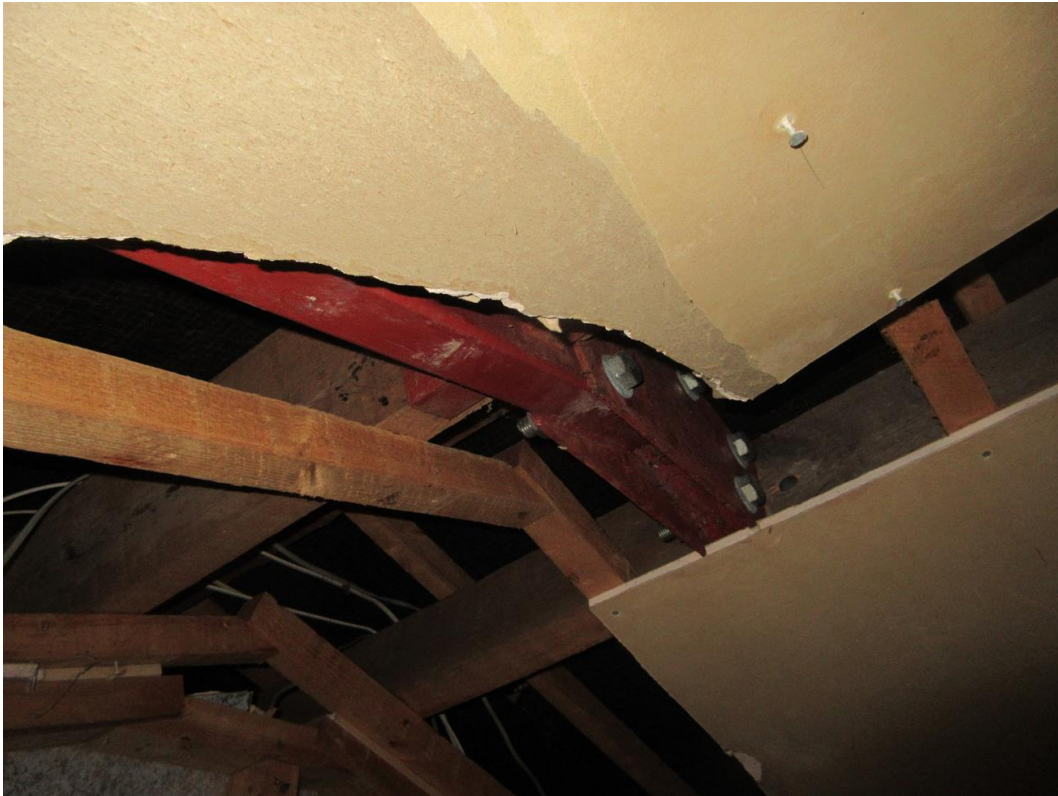
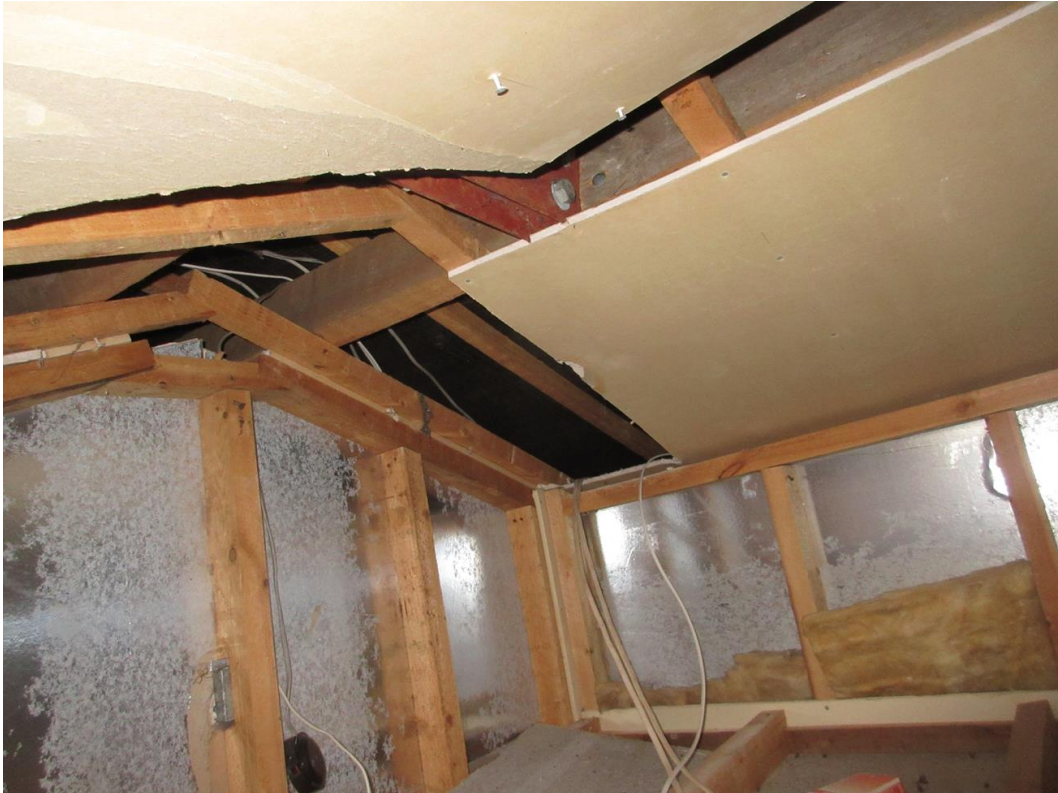
The 90 x 50mm box steel column sections were originally zinc rich primer painted. The upper sections of the steel frame, where viewed, generally were found to be in a reasonable structural condition apart from the lower cast in sections of the columns (019 and 020).

It is difficult to be precise about the estimated future service life expectancy of the main steel columns without detailed information about the actual condition of each section. However, based on the evidence gleaned with the endoscope, it is not unreasonable for the main steel frames to be serviceable to carry the applied dead and imposed loads for a further period of about 10 to 15 years without any intervention repair or upgrading. It is thereafter quite feasible to further extend the service life of the existing steel frame by welding new steel sections onto the lower parts of the existing frames.

- New Welded Repair Sections to Lower Column Sections to Primary Steel Frame.
- Replacement of Existing External Concrete Panel Façades (inc Windows and Doors) & Internal Linings. New Building Wall Envelope to be Insulated and Building Regulation Compliant.
- Replacement of Internal Linings to Roof Slope with Fully Insulated Material.
- Replacement of Mechanical & Electrical Systems.

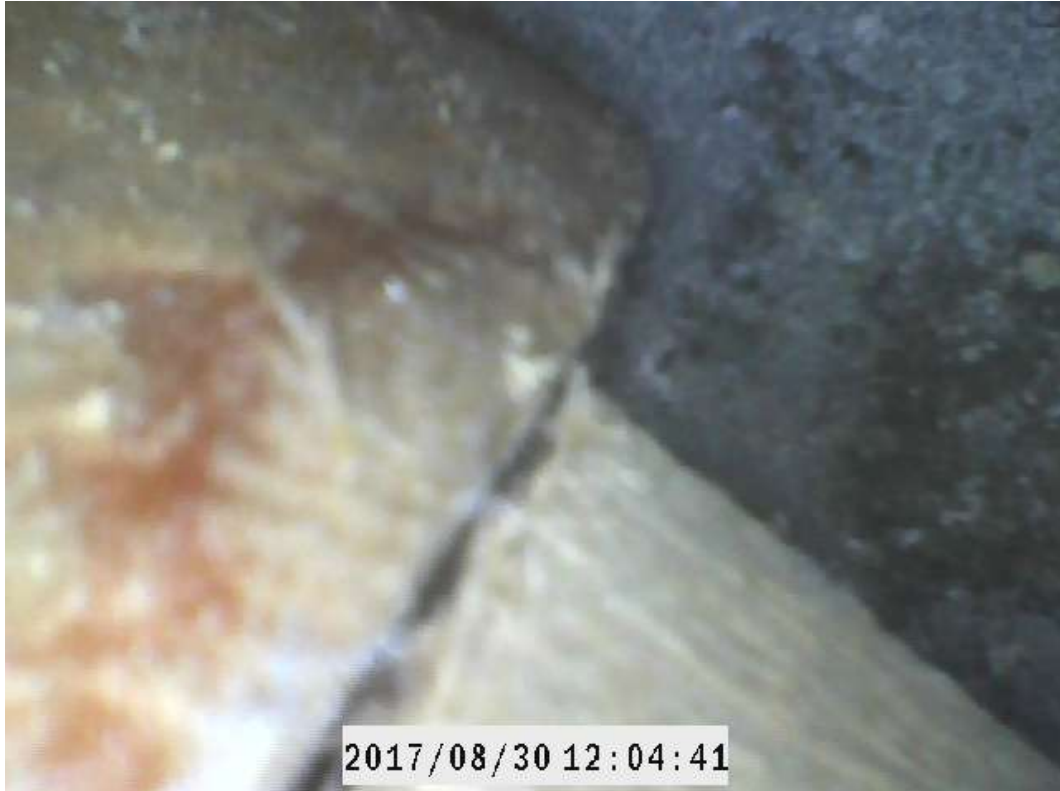
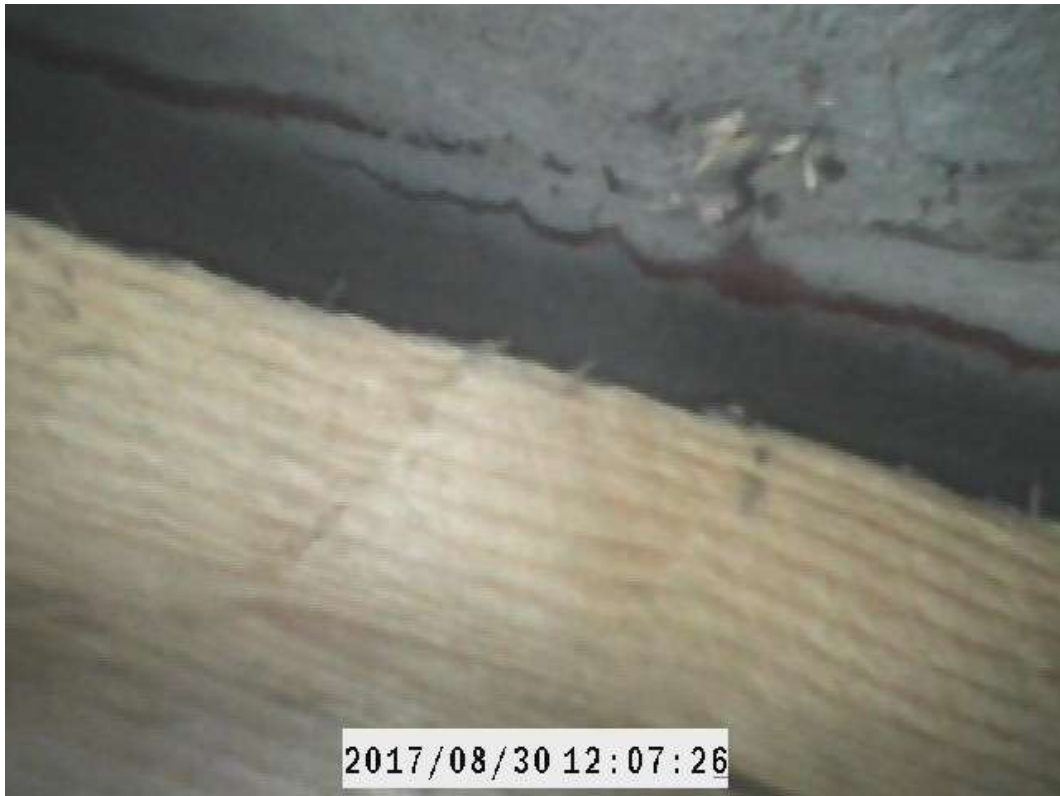
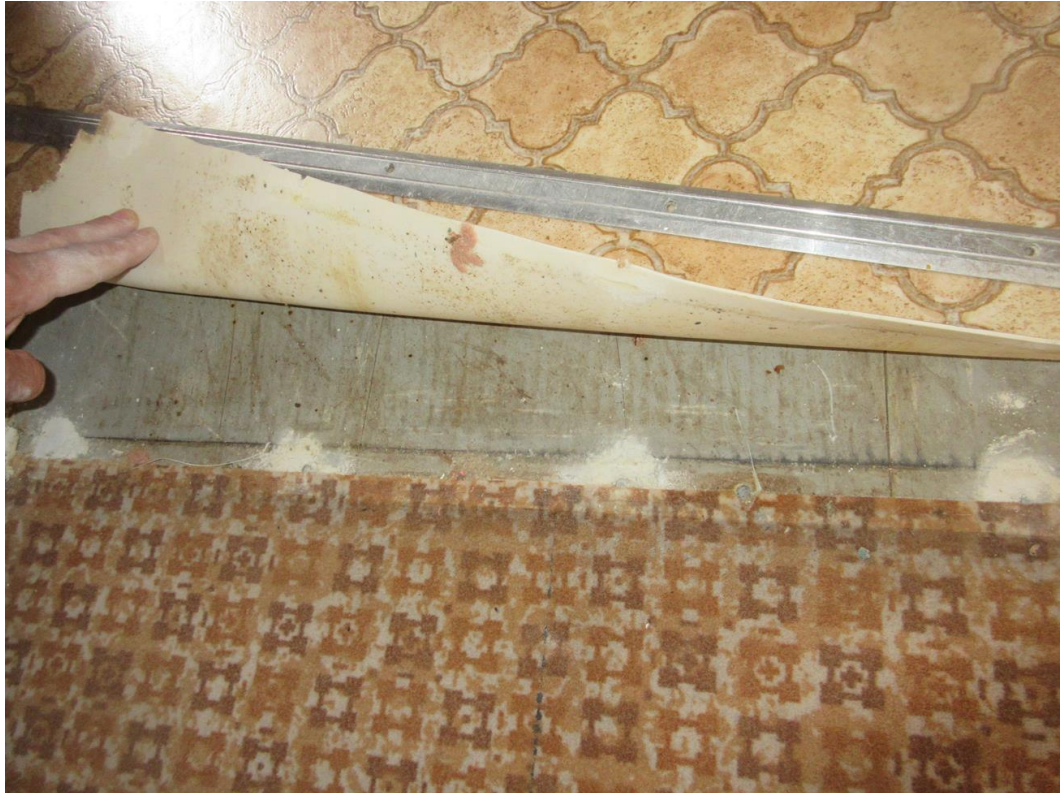
The endoscope review of the steel columns in three places showed that general light surface corrosion of the sections has taken place, more towards the ground floor level, with some surface areas more locally blistered, which indicates that the corrosion levels were higher in these zones and more developed (021 and 022). The reason for corrosion levels being higher in the lower sections of the column is due to the fact that the supporting concrete and screed are damp and have been cast directly around the steel sections. The "Marley Floor Tiles" bonded to the top surface of the screed were then installed not only as a floor covering but also the damp proof membrane (023 and 024).

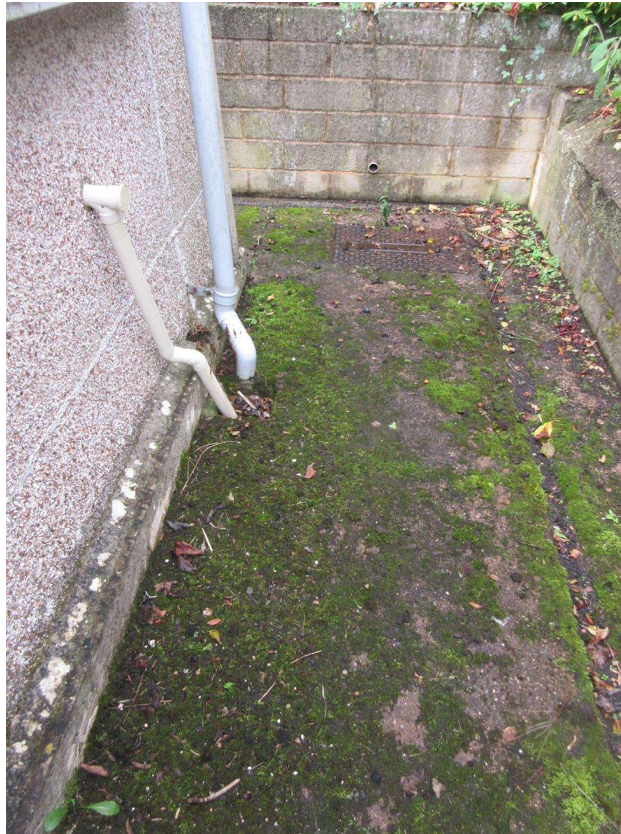
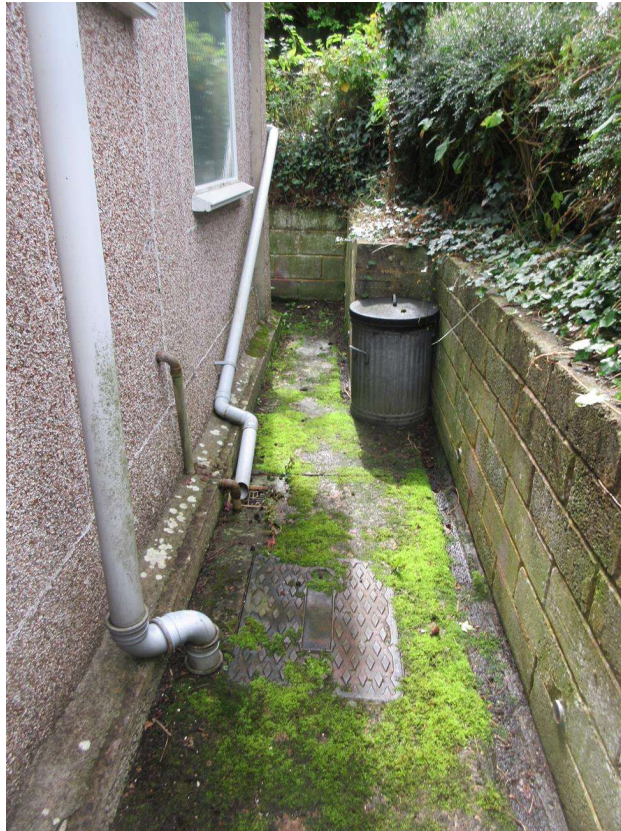
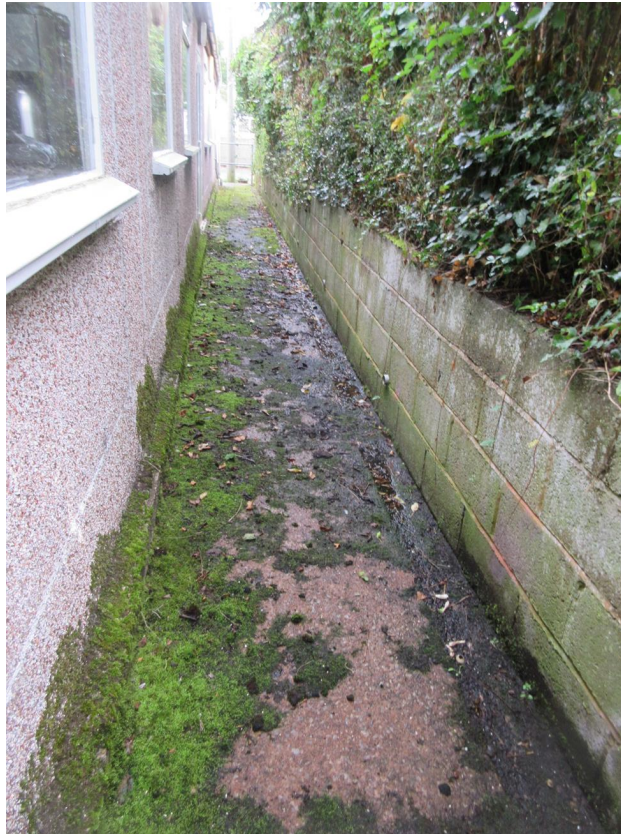
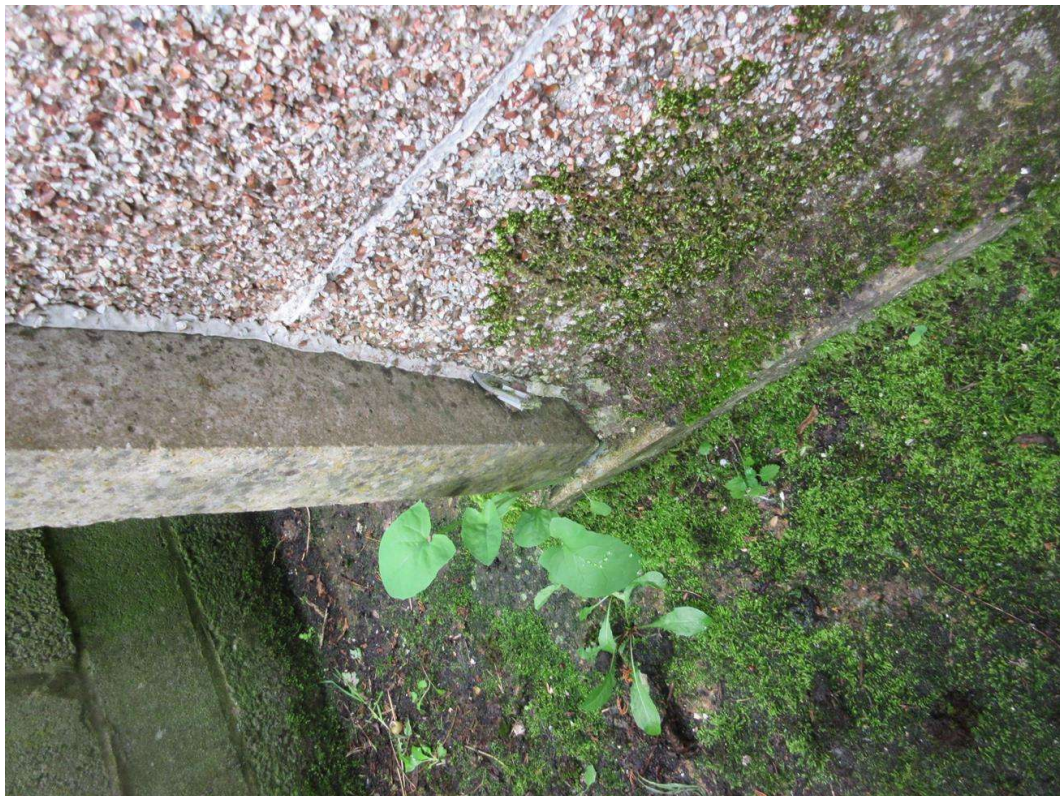
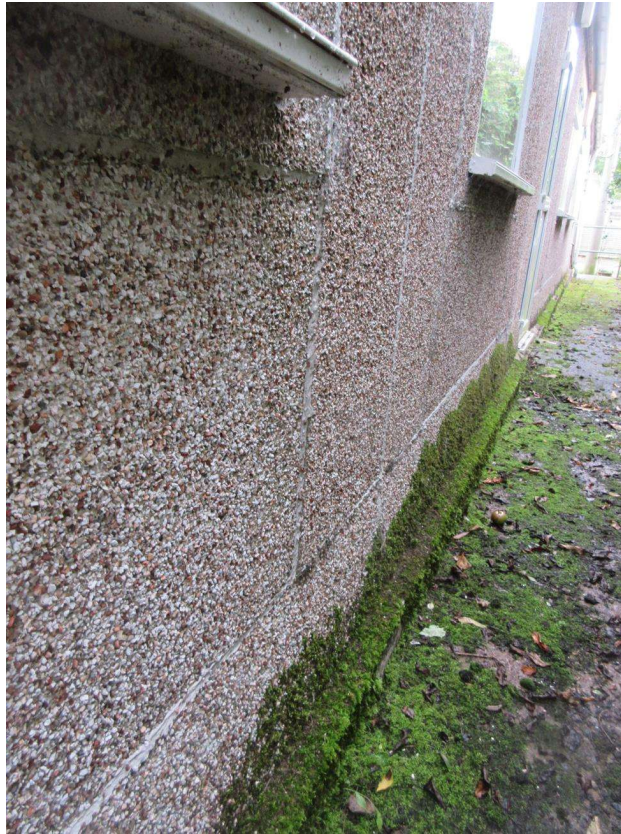
The external concrete hardstandings around the building are in an unkempt condition, it is moss covered and un-swept, which is allowing excessive water retention on the concrete surfaces which further compromises the condition not only of the surrounding slab but the building's foundation concrete and the lower edge of the pre-cast concrete cladding panels. The degree of wetness within the concrete structure will also impact on the corrosion levels and rates of corrosion occurring to the main steel frames columns connected to the concrete (029 to 033 inclusive).

The drainage channel within the concrete surface is partially blocked which restricts the egress of the surface water to the drainage system.

- Camera inspect the surface & foul drainage systems in more detail.
- Inspect & clean out the gutters, down pipes and hardstandings.
- Carry out Demolition & Refurbishment Asbestos Survey.
- Specialist to survey Mechanical & Electrical systems.

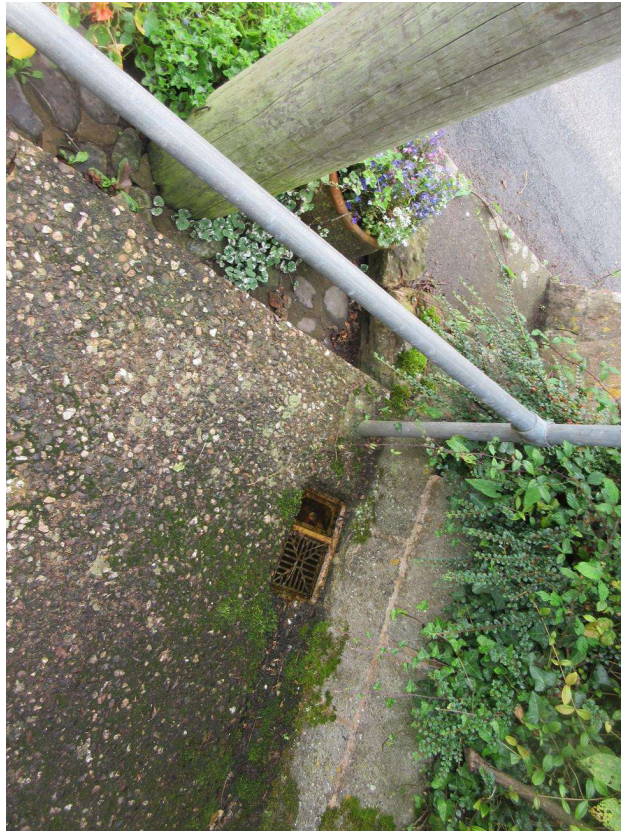
034

The surface water gully at the front of the building was full of water and appeared not to flow away, the adequacy and function of this drain is questioned (034). A digital drainage survey of both the foul and surface water systems needs to be carried out around the building and the intactness of the water main also needs checking.

A detailed and careful inspection of the foul and surface water systems needs to take place, it is believed that some repair and upgrading of the foul and surface water systems may need to take place.

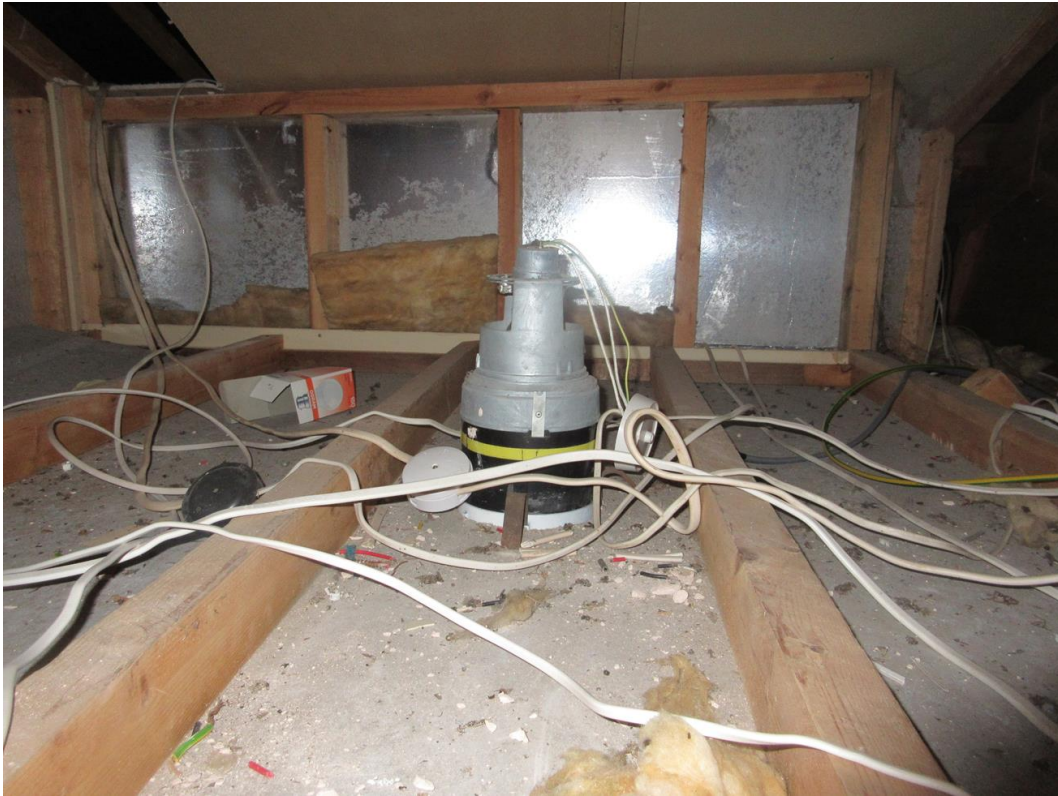
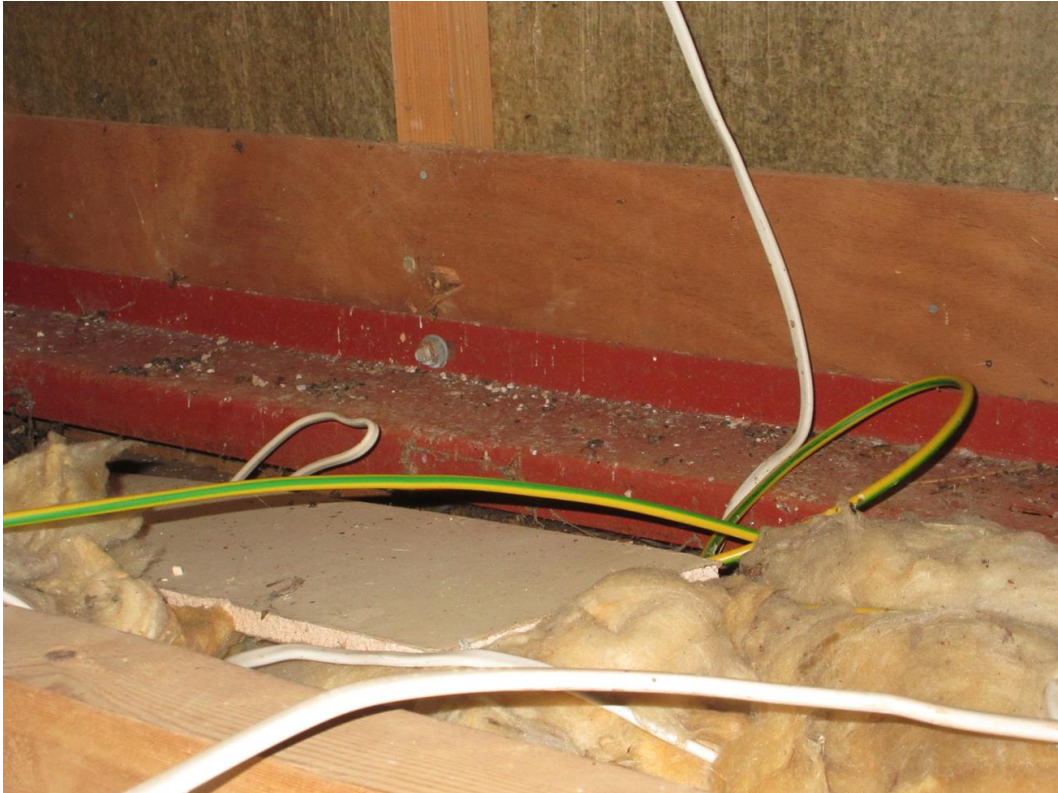
The services within the building were not inspected and where mentioned have been done so in passing only. The mechanical and electrical services should be reviewed and commented upon by a specialist (035 and 036). A utility supply pole is sited nearby in the front corner of the plot near to the building, the service wires run overhead to the other surrounding properties. Any outside work to the building will need to be controlled by working to Method Statements to limit the dangers of working within the vicinity of the services.
